WATER FOR SCHOOLS IN MIGORI COUNTY A PROJECT REPORT FOR SANGO PRIMARY

The Context

The project began on July 31 and was successfully completed on August 13th, 2024.

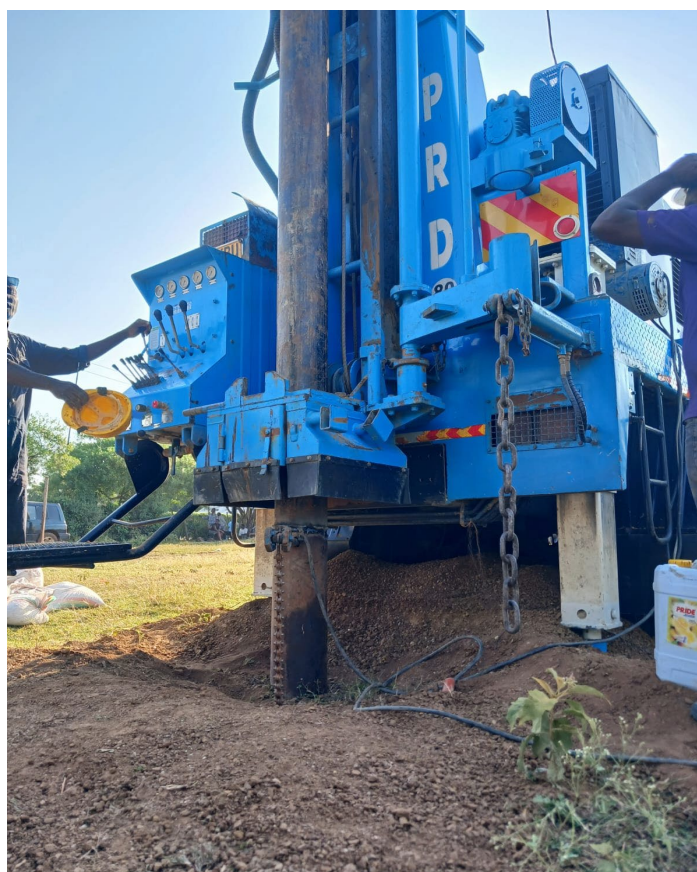
Installation of surface casing at Sango Primary School

1. We encountered long columns of loose conglomerate rock formation that necessitated the use of surface casings. This was a huge challenge given that we didn't envision such and didn't factor it in on our preparation plans. At some point, our drilling rods got stuck but due to the technical know-how and capability, we managed to retrieve rods after

much struggle. We then continued drilling after we had retrieved the rods and acquired surface casings

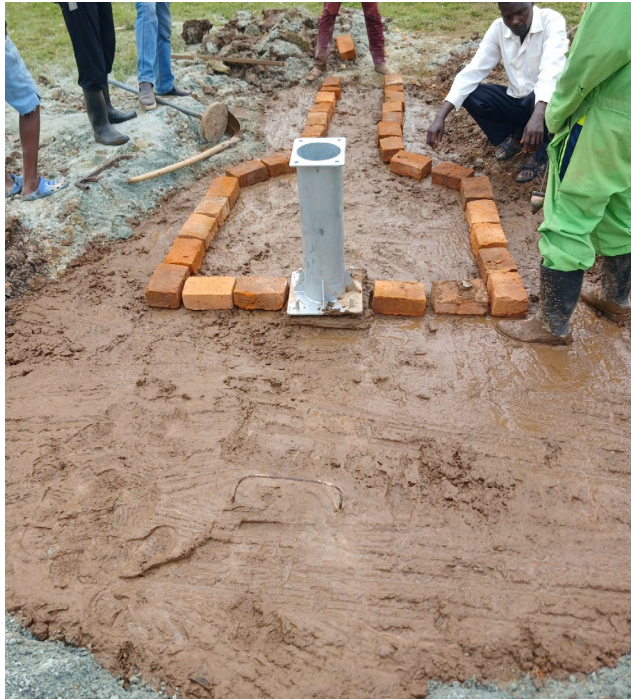
Ongoing Pad Construction

After sharing the laboratory results with the beneficiaries - who were very happy - we moved into the last phase of the project. This entailed the pad construction and pump installation of the borewells.

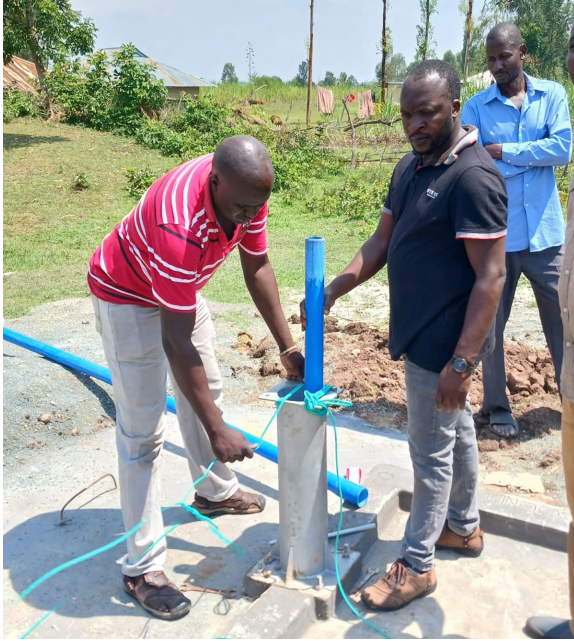
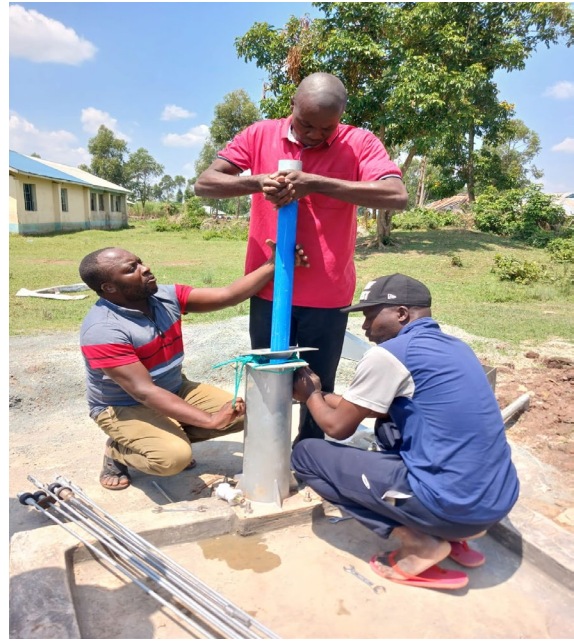
Pump Installation Underway
